# Manhole Inspection Summary

Manhole # S31C\_\_002MH

Insp Date: **5/26/09 3:36 PM**

**Location** Address: **MULBRRY ST**

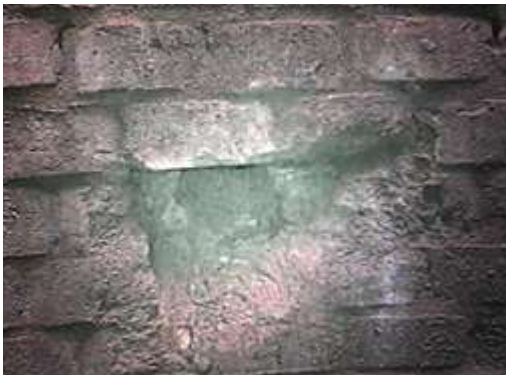
Defect 1

**Barrel** Material: **Brick** ☐ Parged

Condition: ☐ Sound ☐ Cracked ☐ Root Intrusion ☒ **Loose Brick** ☒ **Deteriorated**

BARREL WALL MISSING BRICK

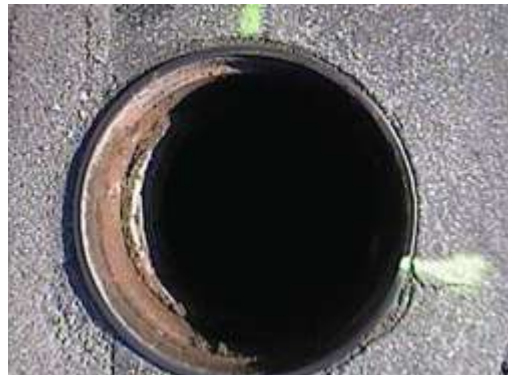
Defect 2

**Frame** Offset: **3** (in.) Condition: ☒ Sound ☐ Cracked ☐ Leaks

FRAME OFFSET

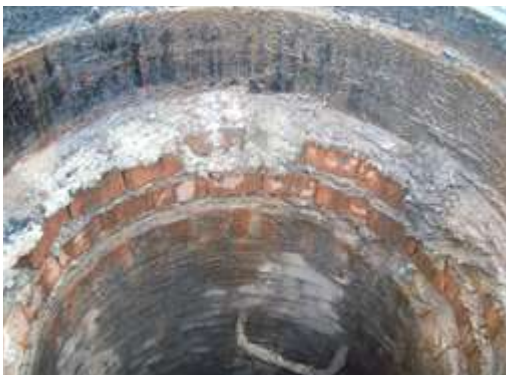
Defect 4

**Chimney / Frame Adjustment** ☒ Exists Material: **Brick** ☐ Parged Height: **10** (in.)

Condition: ☐ Sound ☐ Cracked ☐ Root Intrusion ☐ Loose Brick ☒ **Deteriorated**

DETERIORATED CHIMNEY

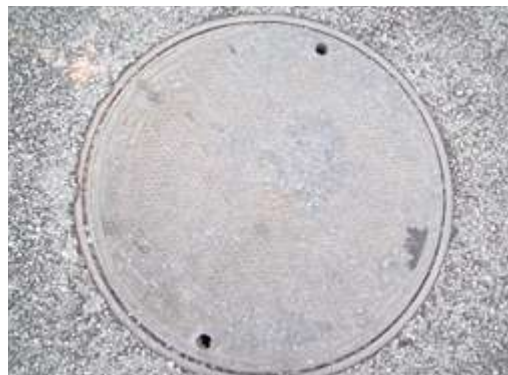
Defect 3

Type: **Sanitary** Condition: **Worn** Cover Material: **Cast Iron**

WORN COVER

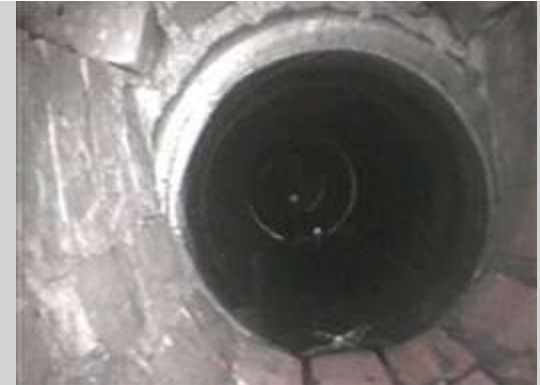
12 O'Clock Outflow

10 in. Circular Gravity Sewer  
Pipe Out @ 12 O'Clock

Infiltration: **None** Pipe Seal Cond: **Sound**

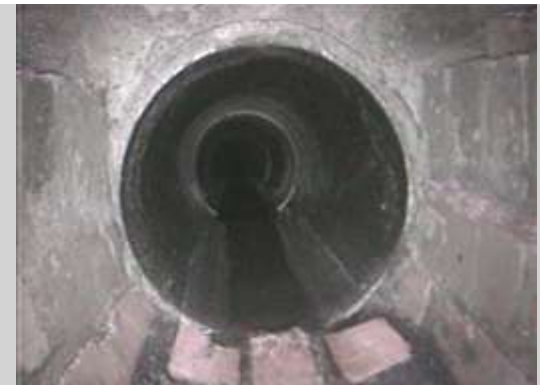
3 O'Clock Inflow

10 in. Circular Gravity Sewer  
Pipe In @ 3 O'Clock

Infiltration: **None** Pipe Seal Cond: **Sound**
